**PROGRAM FOR EXPERIMENTAL INVESTIGATION OF FAILURE
PROGNOSIS OF HELICOPTER GEARBOXES**

**Northrop Research and Technology Center
3401 West Broadway
Hawthorne, Calif. 90250**

August 1976

Final Report

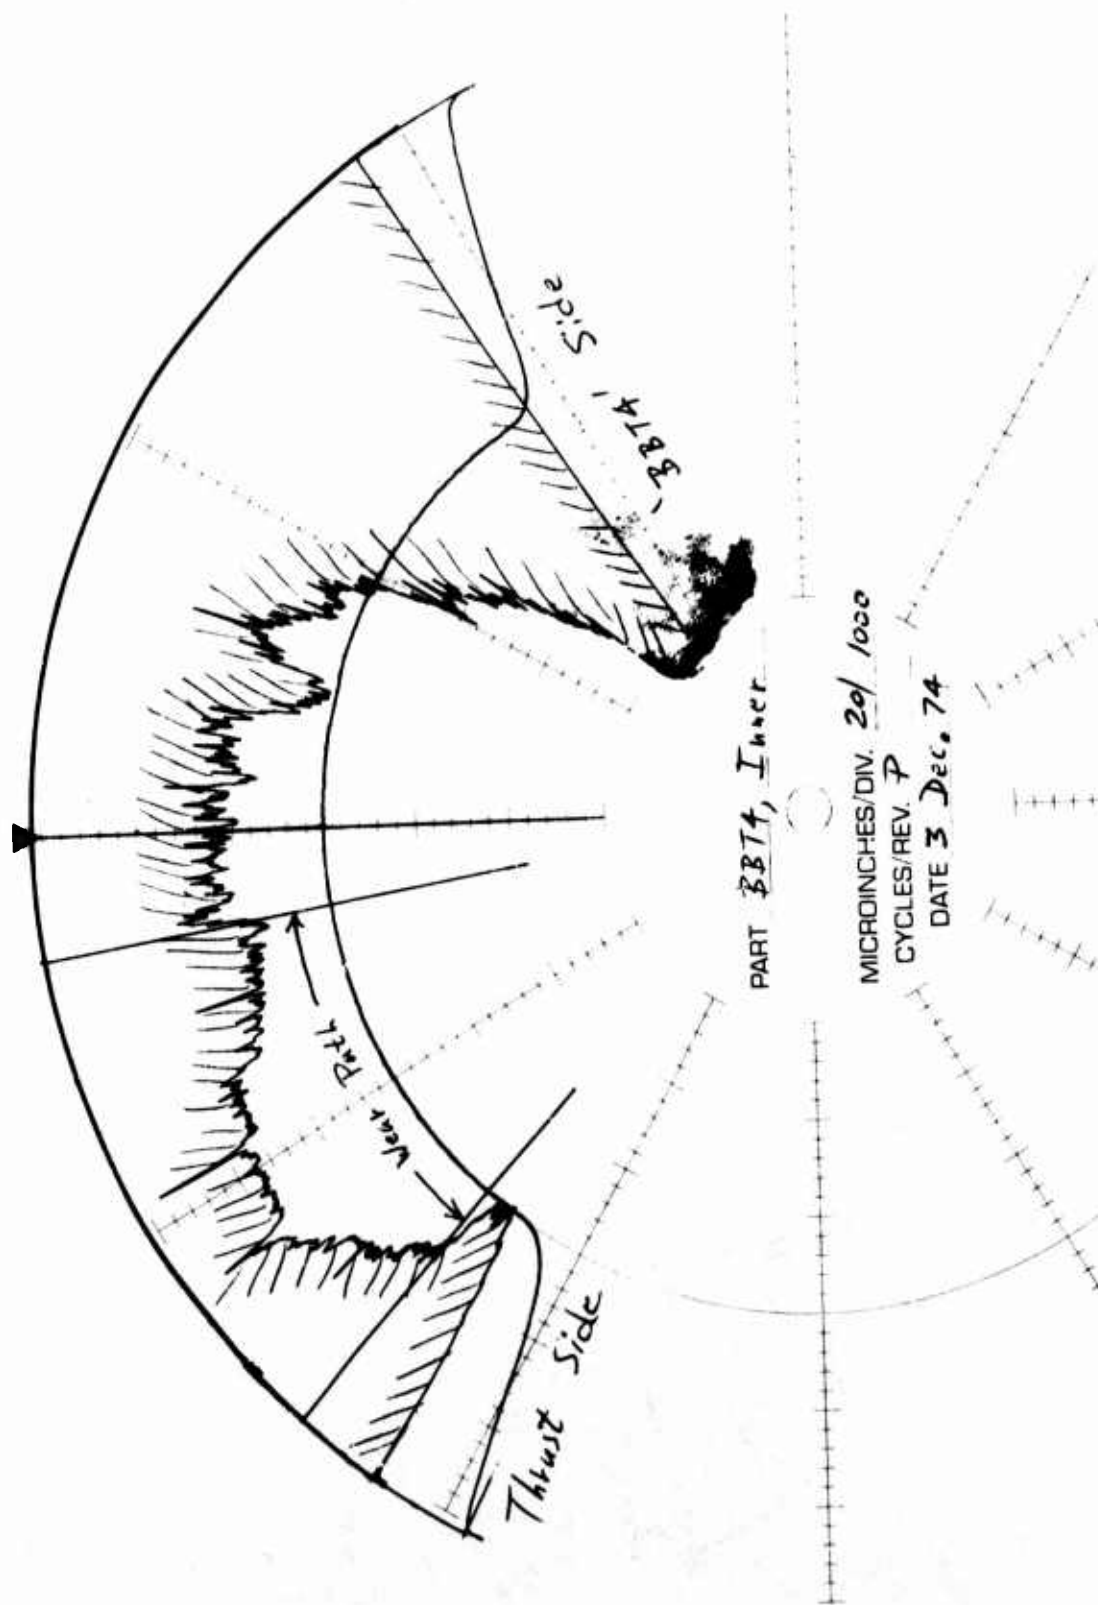
Figure 152. BBT-4 Cross-Groove Profile at 1022 Test Hours.
